# Silver King Fire Burned Area Summary

## Burned Area Report

## Silver King BAER

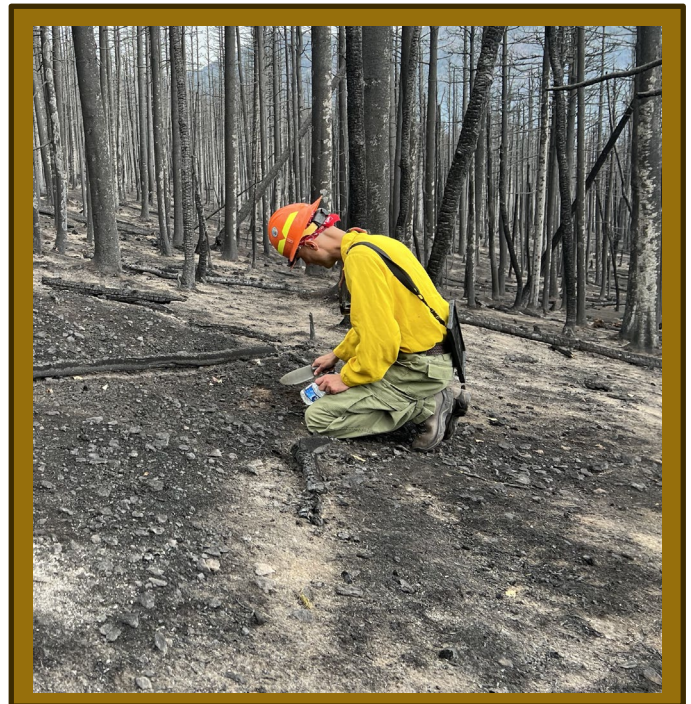
*Figure 1: BAER Team member assessing soil burn severity in Bullion Canyon*

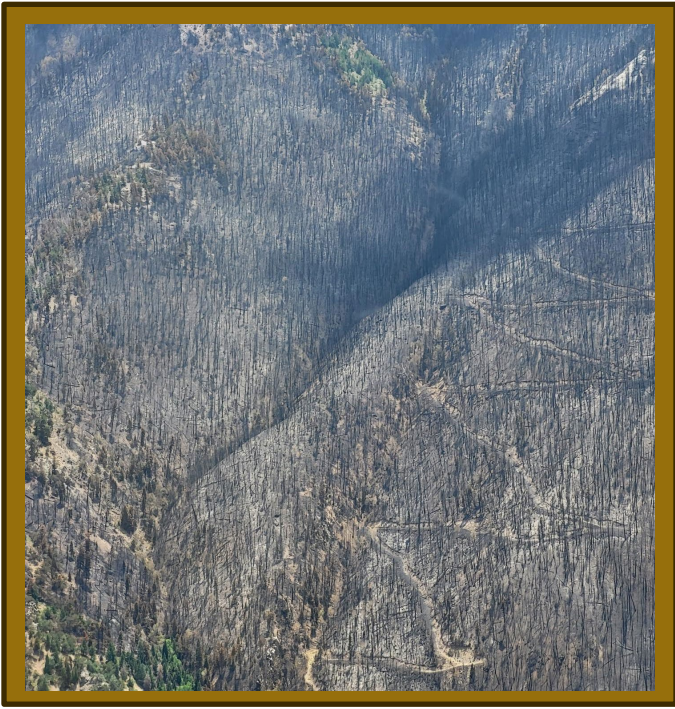
*Figure 2: Moderate and high soil burn severity above Miners Park in Bullion Canyon*

Mapped and validated SBS for the burned area is High (12%), Moderate (48%), Low (36%), and Very Low/Unburned (4%) (see map on page 7). The more severe a fire's effects are on the soil, the more likely those soils will erode in subsequent rainstorms – especially in locations with steep slopes. Erosion after fires can cause tremendous damage to homes and other structures in the years after a fire.

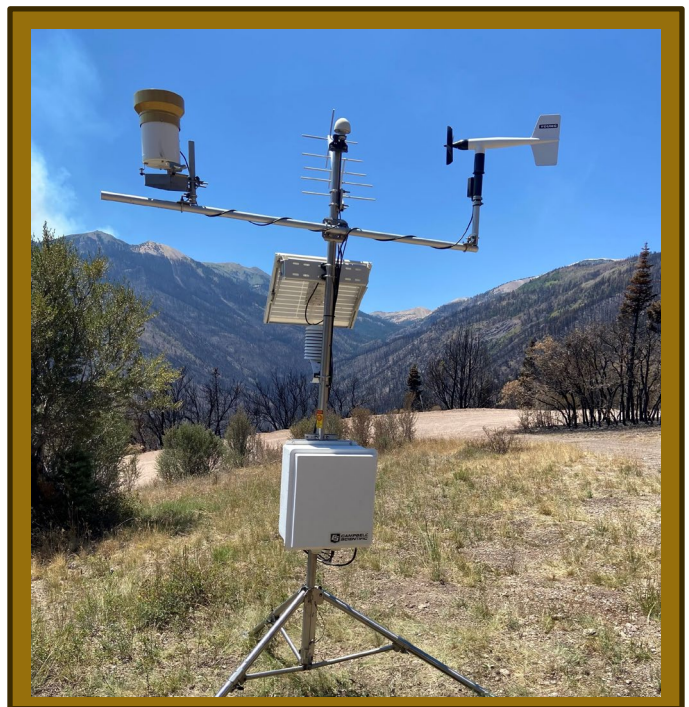
*Figure 3: Three early warning weather stations have been deployed in the burn scar by the National Weather Service and Utah Department of Transportation.*
